Erie to Pittsburgh Trail: Chautauqua County

Section 2: East 6th Street to Pecor Street

Section 3: Pecor St. to Chautauqua Rail-trail

Section 6: Corry Junction Greenway Trail

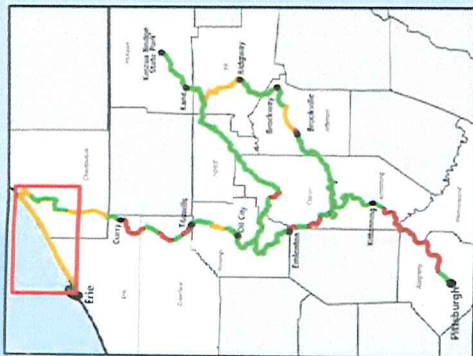
At East 6th St. (Rt. 5), the proposed corridor departs the East Bayfront Parkway and follows the road eastward. The intersection of the East Bayfront Parkway and Rt. 5 is busy, with multiple lanes in each direction. Once on Rt. 5, there are 2-3 travel lanes in each direction for approximately 3.5 miles until the intersection with Rt. 955. This section of the highway has minimal to no shoulder in a few spots. Eastward of Rt. 955, the shoulder conditions improve. Rt. 5 is also known as the Great Lakes Seaway Trail and is part of PA Bicycle Route Z, and is a signed, mapped scenic byway that parallels the shores of Lake Erie northeast towards Buffalo, NY. It has a posted speed limit of 55 mph and a moderate traffic volume. Road surface and shoulder width varies throughout its length. Near Erie, the road surface is older and deteriorating in spots, while the New York side was recently resurfaced and has wide shoulders with a rumble strip separating the shoulder from the road. The road is generally fairly straight and flat, only gaining 171 feet in elevation over the 36 miles between Rt. 6 and Pecor St. However, there are small rollers that cause short sight lines for motorists in a few spots, especially at the intersection with Pecor St.

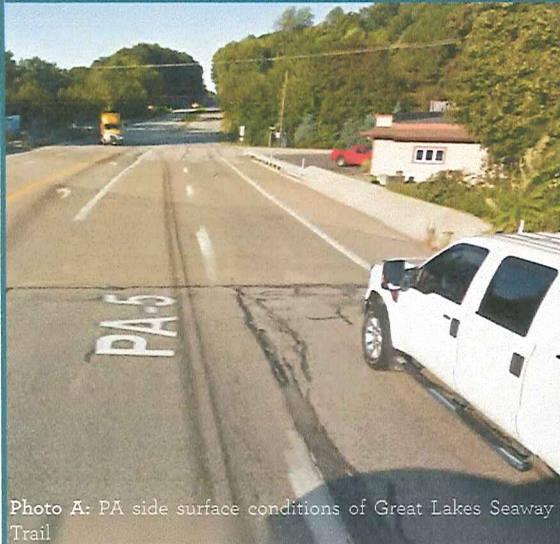
Photo A: PA side surface conditions of Great Lakes Seaway Trail

The Great Lakes Seaway Trail is recognized as a National Scenic Byway by the U.S. Department of Transportation but could be better marketed to non-motorized use with some improvements. Sharrows or a dedicated bike lane on the Erie end of Rt. 5 and a wider shoulder on the more rural sections, and share the road signage, would help improve the safety of cyclists and pedestrians using this connector. A coordinated effort between the states to improve this corridor would be an improvement.

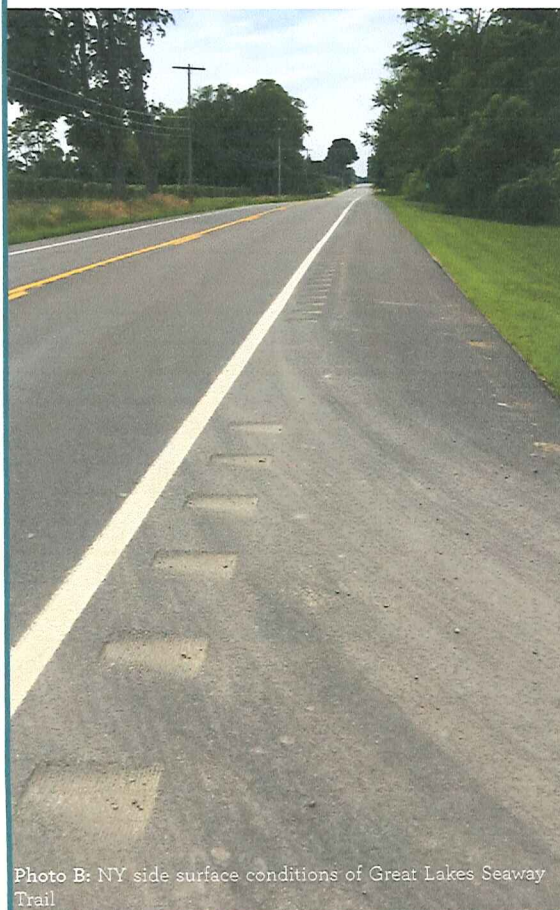
Photo B: NY side surface conditions of Great Lakes Seaway Trail

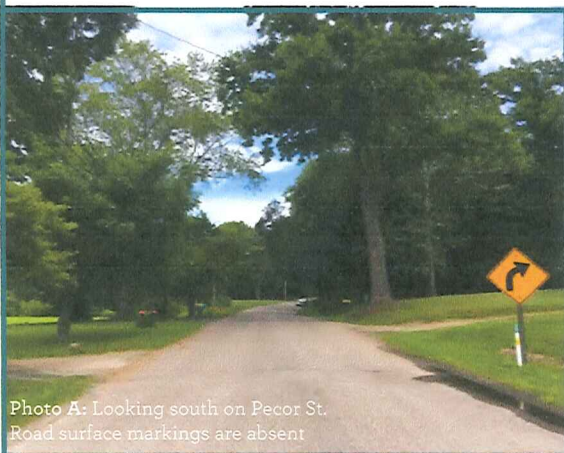
Pecor Rd. is a low-volume local road generally in good repair though it appears to have been 7-10 years since its last resurfacing. This stretch of Pecor Rd. lacks lane marking and is relatively level in grade. Visibility is high, though some mature trees line the roadway. The primary trail alignment turns eastward from Pecor Rd. onto Fuller Rd., with conditions remaining similar to Pecor Rd. From Fuller Rd. to the northern terminus of the Chautauqua Rail-trail, the route makes a few turns in quick succession. For these sections, surface quality of the asphalt is consistent and in good repair. For approximately 500', the alignment utilizes Rt. 20 in Brocton. NYDOT identifies Rt. 20 as a Rural Principal Arterial Other roadway. Based on observations, this section of Rt. 20 sees moderate traffic volume. It is posted for 35 mph for 100' near the intersection with West Ave. before changing to a posted school zone for 25 mph.

Photo A: Looking south on Pecor St.
Road surface markings are absent

The intersection of Rt. 5 and Pecor Rd. would benefit from a number of infrastructure improvements to ensure a safe transition for users from the Major Collector Parkway to the local road. Signage on the local roads between Rt. 5 and the Chautauqua Rail-trail would provide a more cohesive trail user experience. Bicycles May Use Full Lane signs could be installed to acknowledge the presence of potential trail users on the short stretch of Rt. 20 in Brocton.

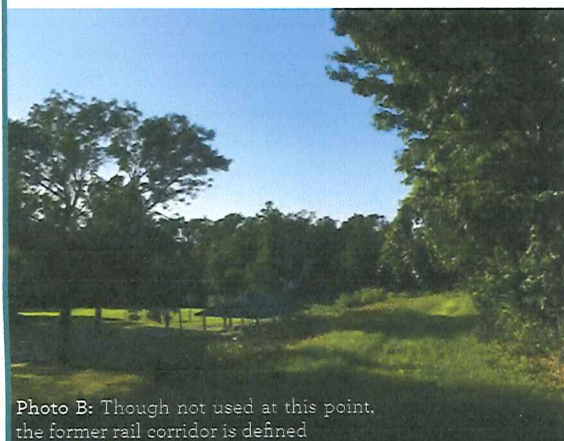
Alternatively, there is potential to use the former rail corridor from the intersection of Fuller Rd. and West Ave. to the beginning of the currently-developed Brocton Area Recreation Trail at School St. The rail corridor appears to be intact and free of encroachments for its 1-mile length between these two points.

Photo B: Though not used at this point,
the former rail corridor is defined

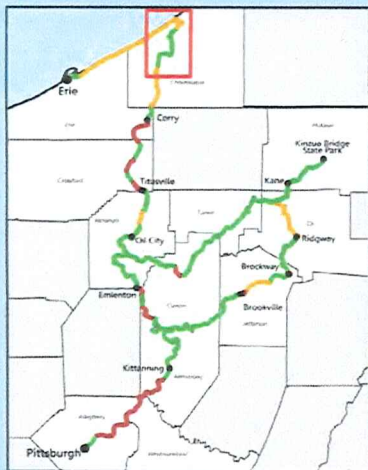
Section 4: Chautauqua Rail Trail

Just west of Mayville, as the trail crosses Sherman-Mayville Rd., there is a significant grade change where there likely used to be a bridge and the trail dips down to meet the road and climbs back up again. The roadside at the crossing is very rough with a mix of rocks and broken pavement creating a potential hazard and signage warns cyclists to dismount and walk. The road is fairly straight with decent sight lines and there is motorist-facing, pedestrian-crossing signage but no crosswalk striping.

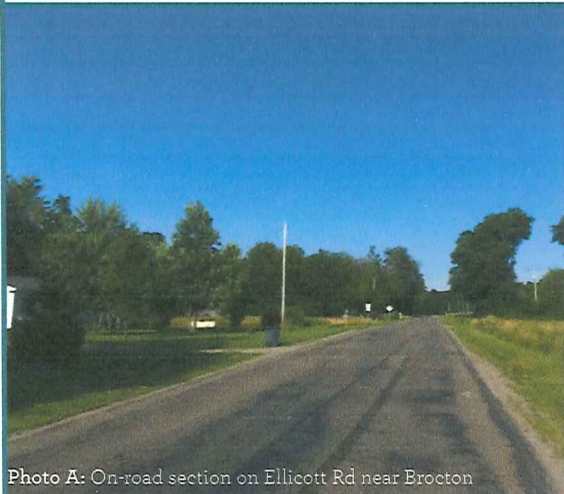
Photo A: On-road section on Ellicott Rd near Brocton

The installation of motorist-facing signage and striping on the roads would increase the safety of the road crossings and share-the-road signage and/or sharrows on the on-road detour sections would help alert vehicles of potential bicycle traffic.

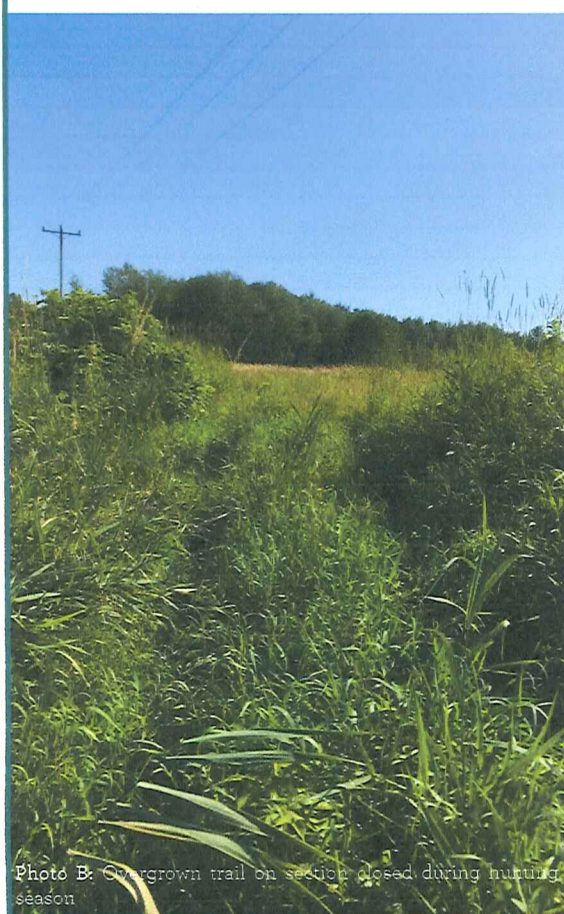
Photo B: Overgrown trail on section closed during hunting season

Approximately 9 miles south of Brocton, there is a 1.3-mile section of the corridor that is marked both on Chautauqua Rail-trail maps and on the ground as closed during hunting season. During the July field work, this stretch was grown in with tall grasses and nearly impassable in spots. A 1.4-mile on-road detour using Plank Road (Major Collector) and Honeysette Road (Minor Collector) take users back to the trail.

Surface consistency and drainage improvements would create a more favorable user experience. Asphalt paving likely isn't the best option in this scenario due to the heavy snowmobile use that the trail sees, but improving the crushed stone surface could be an adequate compromise for all user groups.

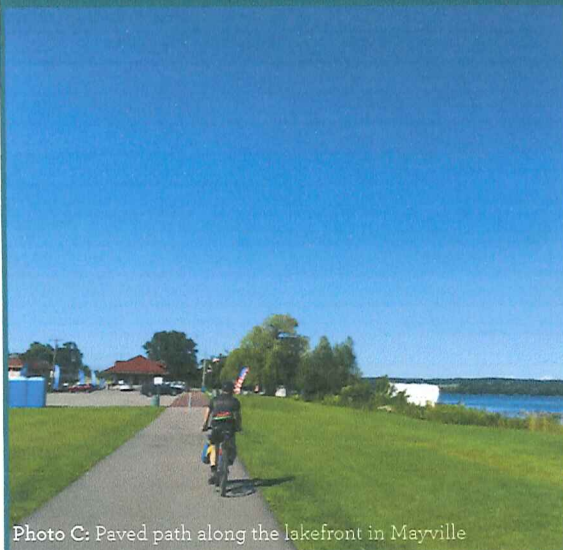
South of Honeysette Rd., the treadway is soft and grass covered for about a mile until it crosses East Chautauqua Street (Rt. 430). From there, the trail is paved for approximately 1.5 miles as it follows the Lake Chautauqua waterfront through Mayville, a small but vibrant town offering amenities such as lodging, food and breweries. The

Photo C: Paved path along the lakefront in Mayville

The section in the town of Mayville can be difficult to navigate, so some additional wayfinding signage for trail users would help to create a more seamless route through town. Signage in town could also direct trail users to amenities and create a stronger connection to the community.

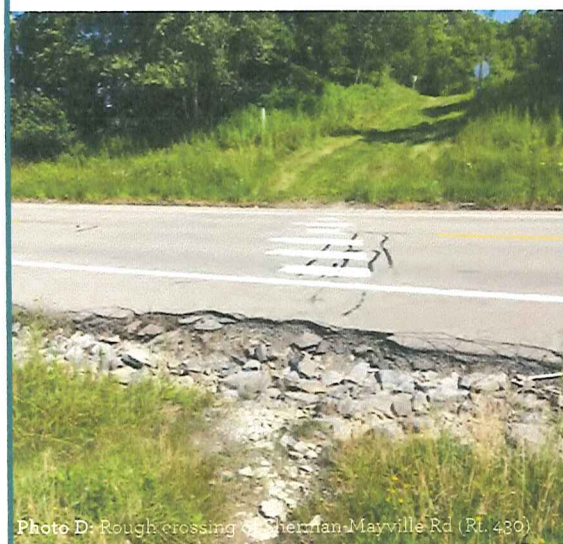
Photo D: Rough crossing of Sherman-Mayville Rd (Rt. 420)

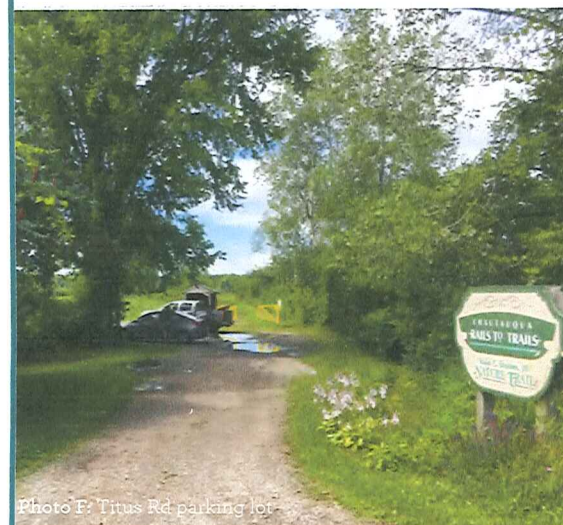
Photo F: Titus Rd parking lot

At Hannum Rd., the Chautauqua Rail-trail follows another on-road detour for 1.4 miles, picking up again on Summerdale Rd. Both of these roads are Rural Local Roads with low traffic volume. The trail passes very close to Chautauqua Gorge State Forest, and a short detour offers camping, hiking and picnicking opportunities. Continuing southward towards Sherman, the trail passes through a mix of forested and marsh landscapes. The treadway remains similar to the other sections with a crushed stone and grass surface interspersed with some muddy spots. It ends at a packed dirt parking area on Titus Rd. that offers room for about 5-8 vehicles and an information kiosk with maps.

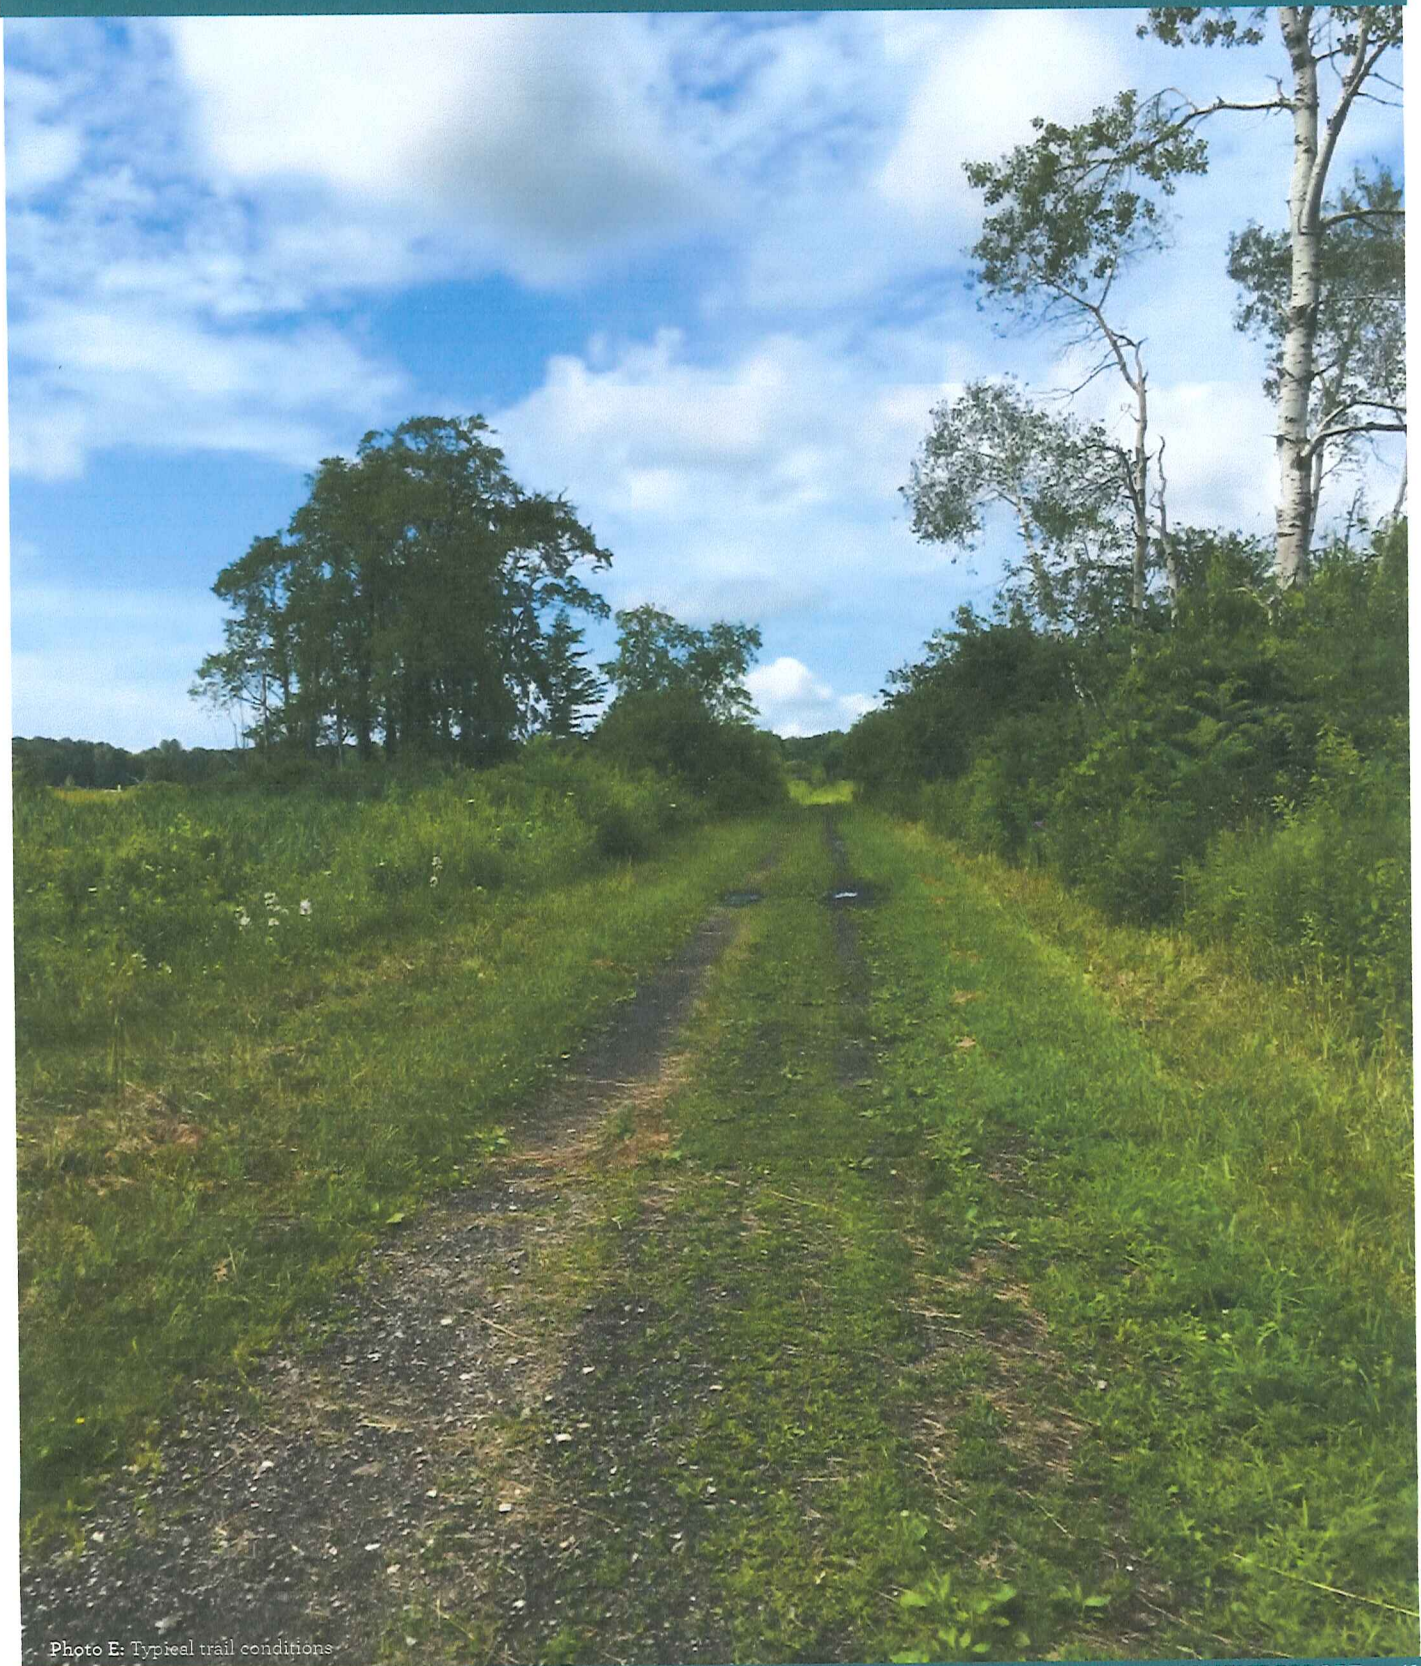
Photo E: Typical trail conditions

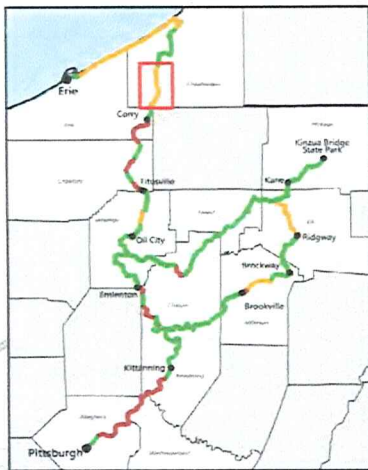
Section 5: Chautauqua Rail Trail to Corry Junction Greenway Trail

The primary alignment for this section involves slightly over 12 on-road miles between the towns of Sherman at the north end of the section and Clymer at the south. Trail users would connect to Sherman by travelling a mix of low-volume local roads with no roadway striping and Rural Minor Connector roads into Sherman proper. The Rural Minor Connector roads are striped, though the striping is considerably faded. On both classes of roadway into Sherman, the asphalt surface is in fair condition with signs of checking and cracking.

Sherman is a small town of about 1,600 residents and features a main street business district with amenities such as restaurants, bed and breakfasts, and a hardware store. Users would travel south from Sherman using NY Rt. 76. The turn from Main Street to Rt. 76 is not signalized, but observed traffic traveled at a reasonable speed of no more than 30 mph. A striped bike lane exists on Main Street as it traverses Sherman proper.

Rt. 76 is a NYDOT roadway that is a Rural Major Connector. As such, traffic frequently moves in excess of 45 mph. The shoulder of the roadway varies from 3' to 5' with an additional 18-24" of gravel and is generally in good repair though some markings are beginning to grow faint. Horse and buggy traffic is evident on the shoulder. About .5 miles from Sherman, Rt. 76 interchanges with I-86. Halfway between Sherman and Clymer, Rt. 76 merges with Rt. 474. Traffic from Rt. 76 is directed to stop before turning onto Rt. 474. Once on Rt. 474, the surface conditions are fair, with noticeable patches and long cracks.

Alternate Alignment A provides a potentially safer connection between the Chautauqua Rail-trail and the Corry Junction Greenway. Avoiding the I-86 interchange on Rt. 76 is recommended. Either the Primary Alignment or Alternate Alignment A would benefit from wayfinding signage for trail users as well as signage directed towards motorists to expect trail users. Neither roadway alignment is wide enough for a dedicated bike lane, but shared lane markings could help with wayfinding as well as setting the expectation for motorists.

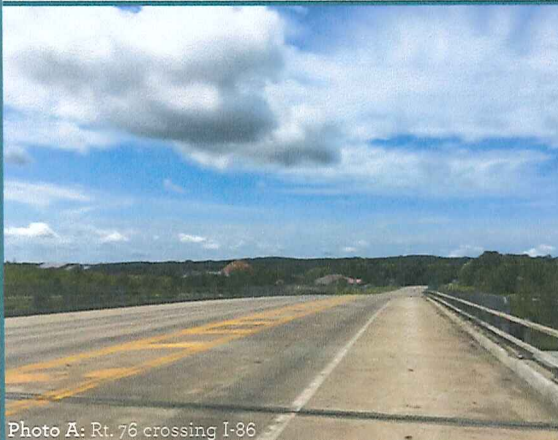
Photo A: Rt. 76 crossing I-86

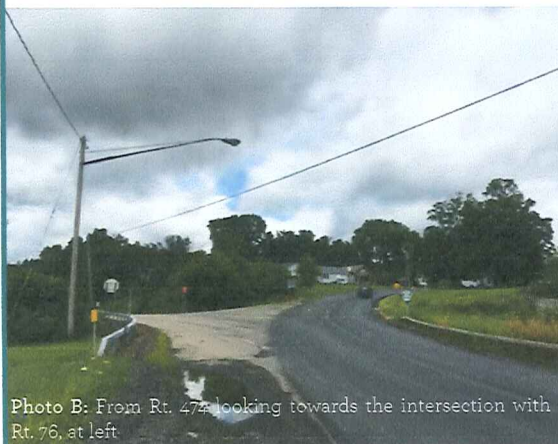
Photo B: From Rt. 474 looking towards the intersection with Rt. 76, at left

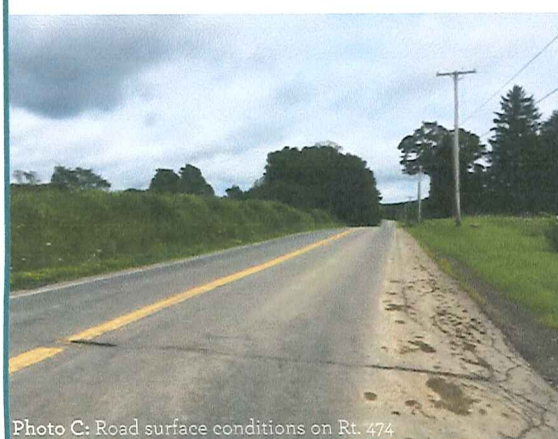
Photo C: Road surface conditions on Rt. 474

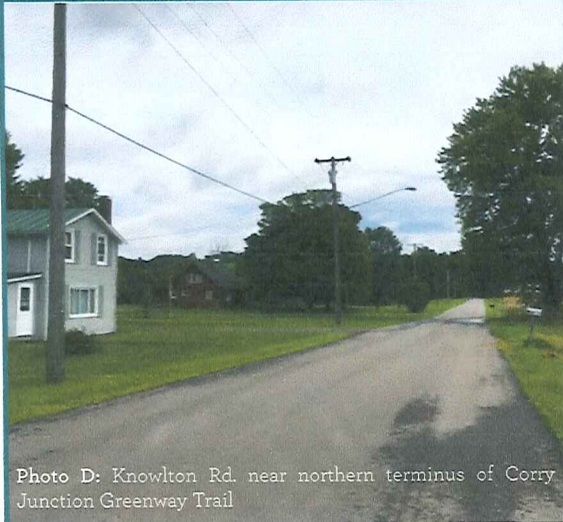
Photo D: Knowlton Rd. near northern terminus of Corry Junction Greenway Trail

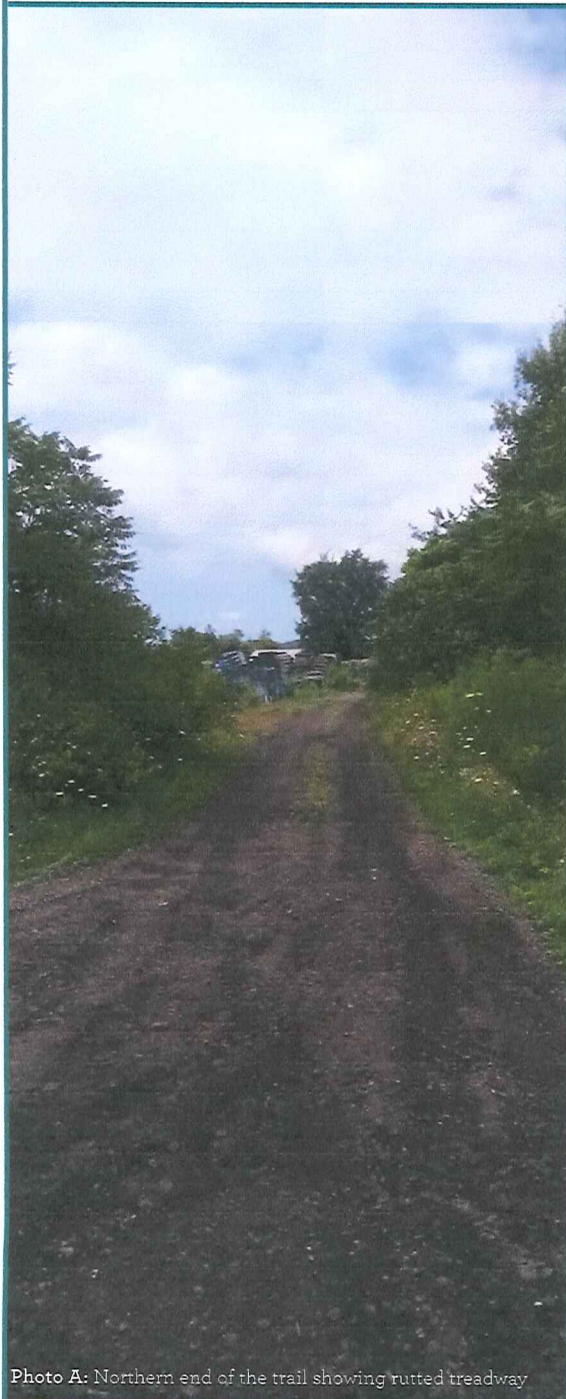
Photo A: Northern end of the trail showing rutted treadway

Section 6 consists of the entirety of the Corry Junction Greenway Trail stretching from Knowlton Rd. in Chautauqua County, NY to North Center St. (PA Rt. 426). The trail's northern point has no distinguishing improvements to identify it as a trailhead. From Knowlton Rd., the trail merely looks like a dirt road access serving the nearby pallet manufacturer. On this initial piece, there is heavy evidence of motorized vehicle use, likely from the pallet company. Stacks of pallets sit in the corridor, though the treadway was clear. Roughly .25 miles from Knowlton Rd., the trail crosses Brokenstraw Creek. Two small, parallel bridges cross the creek at slightly different elevations. The bridges appear to be in sound repair. Between the creek crossing and Knowlton Rd., the trail surface is mostly hard-packed dirt about 8' wide. Treaded tire tracks and light rutting from motorized vehicles using the trail were evident.

The status of the Corry Junction Greenway Trail is Open, Undeveloped. This is primarily due to the fact that it has received little maintenance recently. Dedicated maintenance would potentially elevate the trail back to full Open status. The low-growing vegetation on the treadway should be scraped for the length of the crushed limestone sections and more deeply cleared for the ag land sections closer to the northern end. Weed trimming, especially around the existing benches, picnic tables, and trail signage would create a more inviting trail. All dislodged signage should be replaced to ensure motorists are prepared for crossing trail traffic. On the southern end, improvements to the trailhead in the way of new signage and clearly defined parking boundaries would entice potential trail users to stop and explore. Likewise, the northern terminus would benefit from overall infrastructure improvements and agreements with the pallet company to keep motorized vehicles off the treadway. Map kiosks at both northern and southern trailheads would provide opportunities to connect the trail users' experience to the broader regional context of trails and recreation and inform them of other potential outdoor opportunities.

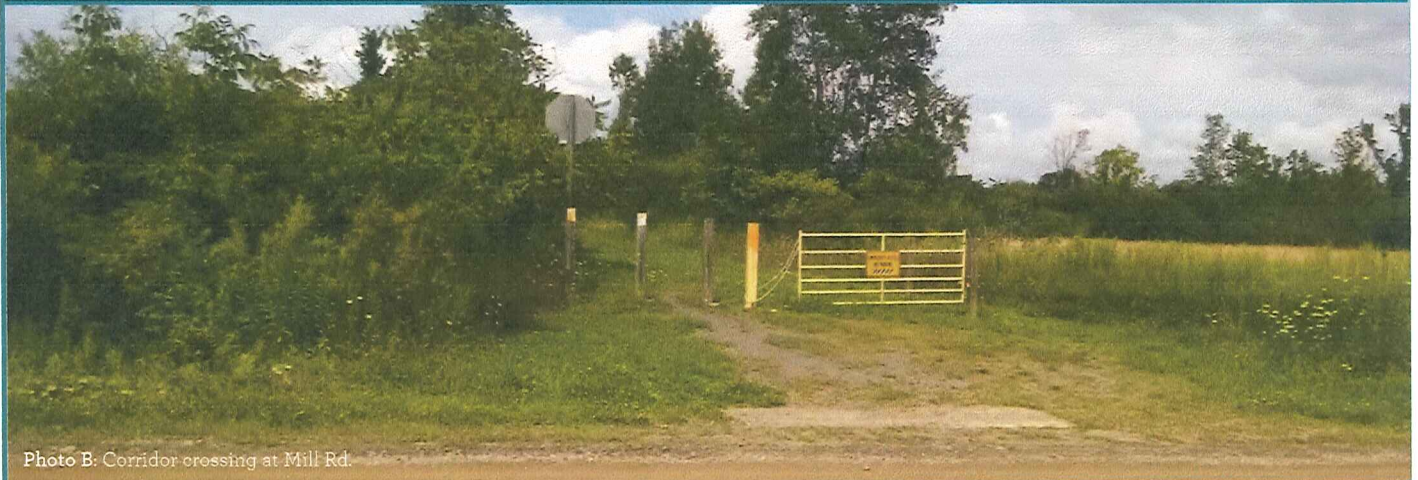
From Brokenstraw Creek to Mill Rd., the main treadway is 8' wide with the overall corridor width being roughly 12'. The treadway is grass, and, although the rolling resistance is high, the ground underneath is compact. This stretch is surrounded by ag land with a thin barrier of trees separating the corridor from the adjacent land in some spots. Overhead canopy is nonexistent. Mill Rd. is low-volume, unpaved farm road. Bollards and a gate allow trail users to pass from the trail across the roadway without allowing motorized traffic onto the trail. Trail traffic is directed to stop before proceeding through the crossing. Sightlines for this crossing are clear, the transition from trail to road is smooth, and the crossing is perpendicular to the roadway. The dirt berm of Mill Rd. is less compact than the center.

Photo B: Corridor crossing at Mill Rd.

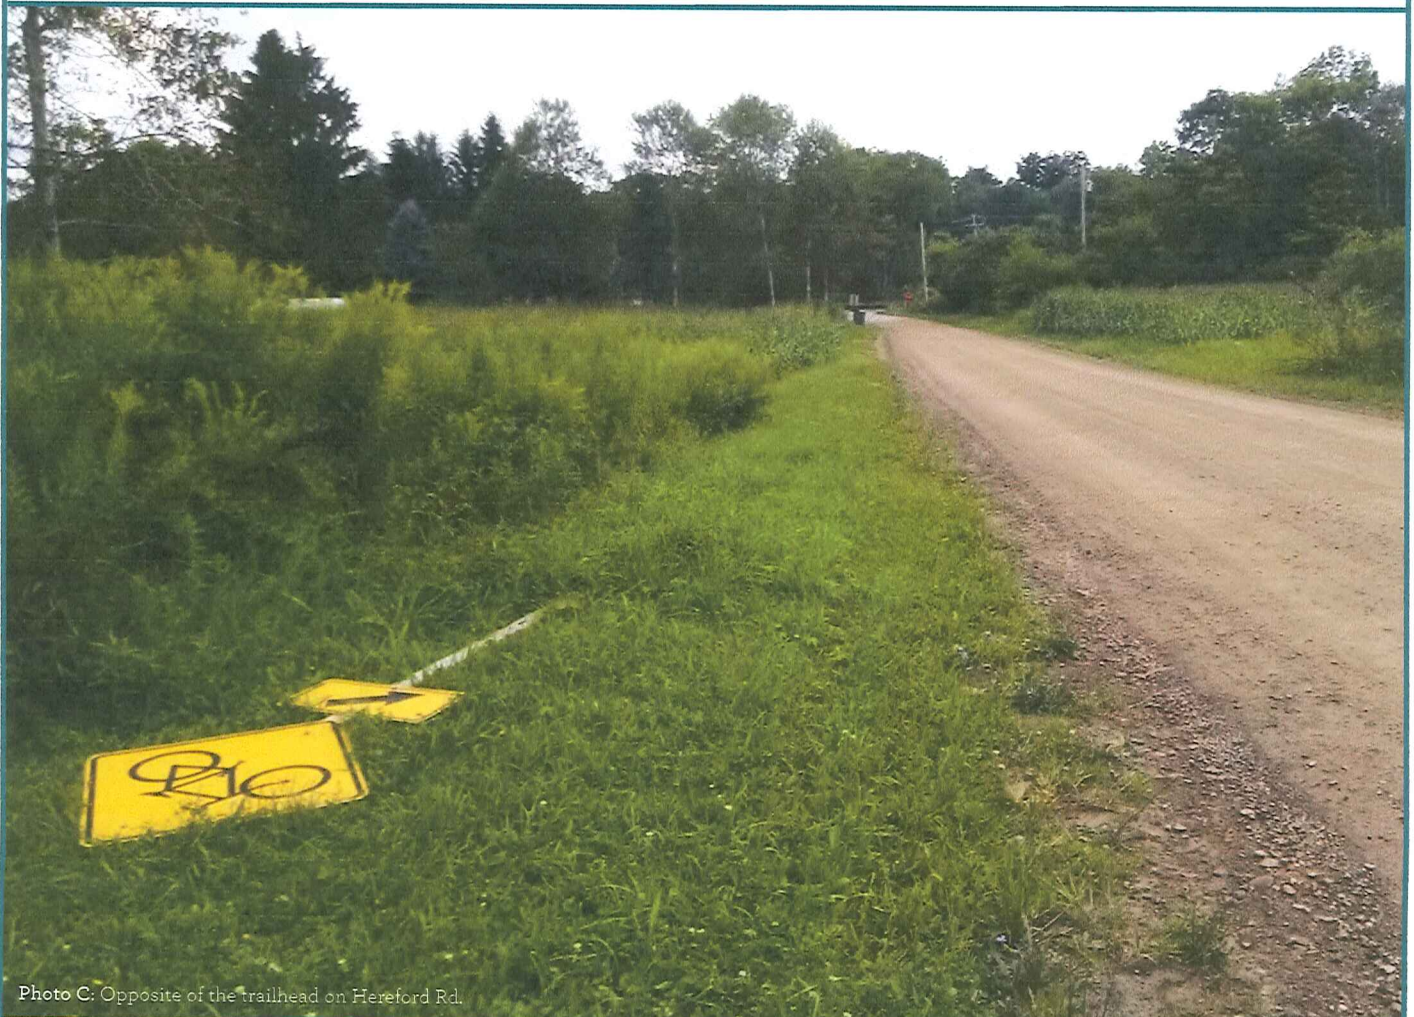
Photo C: Opposite of the trailhead on Hereford Rd.
