# Village of Sherman Comprehensive Water and Stormwater Assessment Studies

*CDBG Planning Grant Public Hearing*

February 5, 2020

# Comprehensive Water Assessment Study

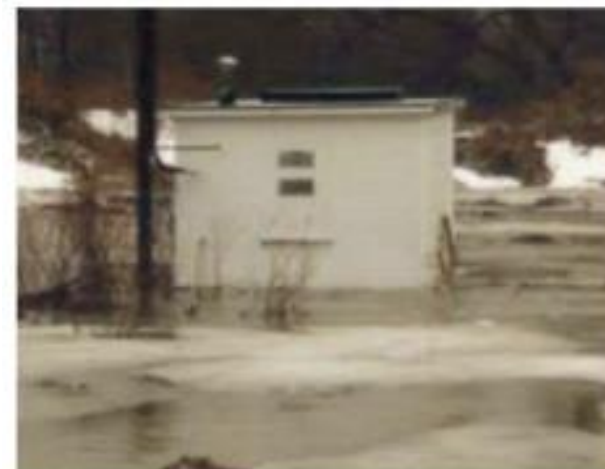
**Historic Photo of Flooding Around Well House No. 2**

| Deficiency No. | Description |
|---|--|
| 6 | Well Building No. 2 is half buried and in extremely poor condition. This well house needs to be replaced in its entirety. The Well Building is located in the 100 year flood plain and is not protected from flooding. This well building has been reported by CCDOH to experienced flooding in the past. These items are noted violations by the CCDOH and can result in untreated surface water entering the public water supply. |

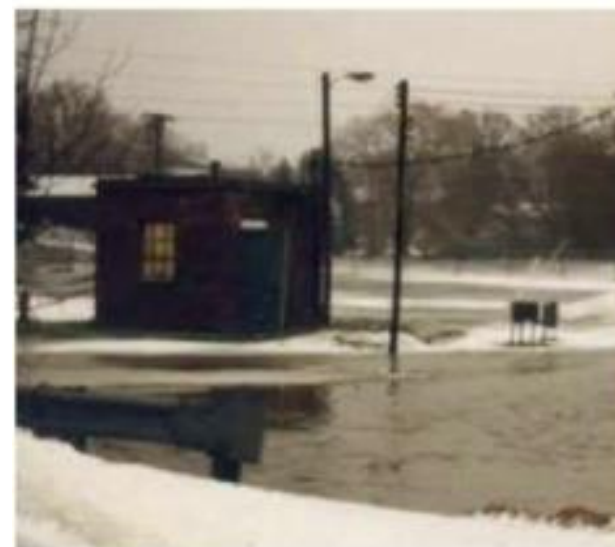
**Historic Photo of Flooding Around Well House No. 1**

| Deficiency No. | Description |
|---|--|
| 5 | Well Building No. 1 requires various minor improvements including new pipe gallery grating, removal of abandoned control panels, and general cosmetic updates and improvements. The Well Building is located in the 100 year flood plain and is not protected from flooding. This well building has been reported by CCDOH to experienced flooding in the past. The lack of flood protecting is a noted violation by CCDOH and can result in untreated surface water entering the public water supply. |

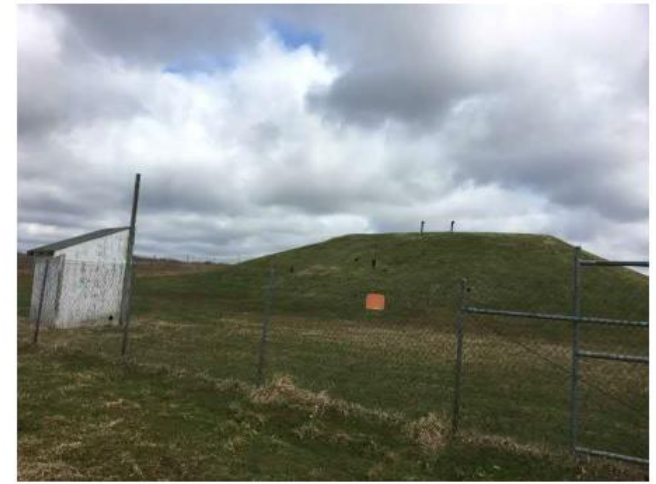
| Deficiency No. | Description |
|---|---|
| 13 | The water tank does not have any level sensor, level alarms, or monitoring systems. Operators have to go the water tank site every day and sometimes multiple times a day to check the tank level and plan well pump operation. This is a noted violation by the CCDOH. |
| 14 | The tank access hatches are located flush with surrounding grade and need to be raised a minimum of 24-inches. This is a noted violation by the CCDOH. |
| 15 | Approximately three (3) homes experience pressures of less than 35 PSI during normal system operation and one (1) house would experience a residual pressure less than 20 PSI during fire flow conditions. This is a noted violation by the CCDOH. |

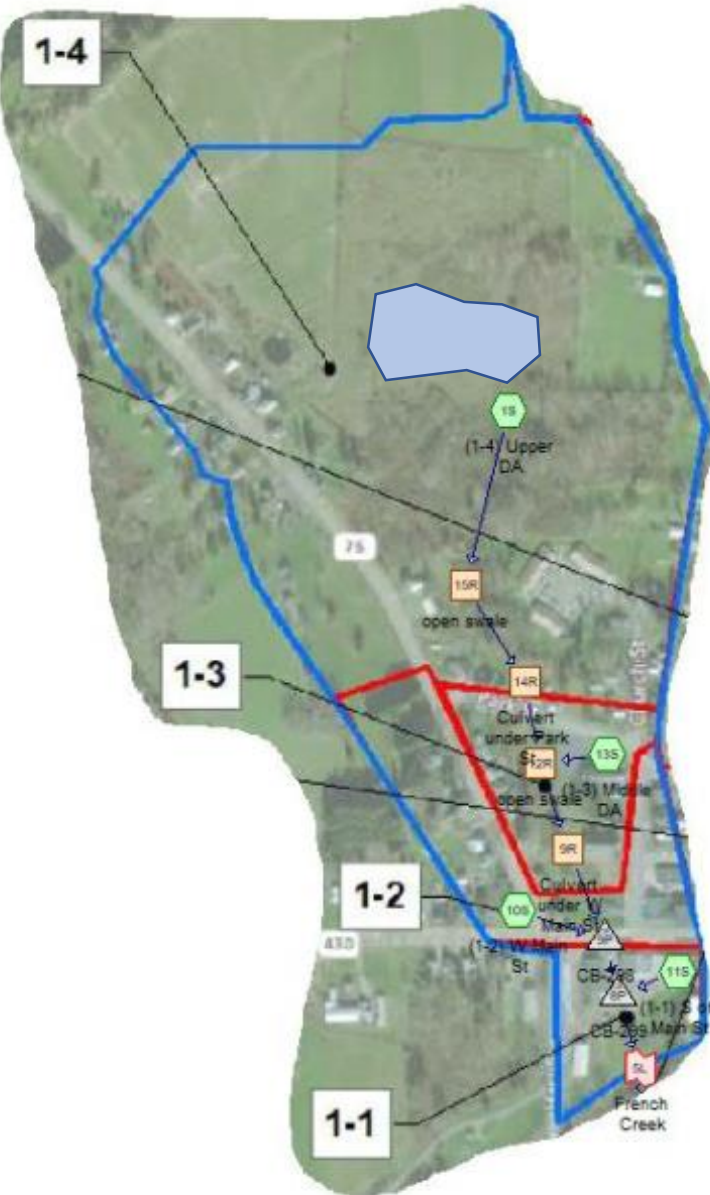
Figure 3-2: DA-1 Model

| Storm Event | Modeled Peak Flow at Outlet (cfs) | Modeled Peak Flow at Outlet(cfs) |
| 1-Year Storm | 59 | 10 |

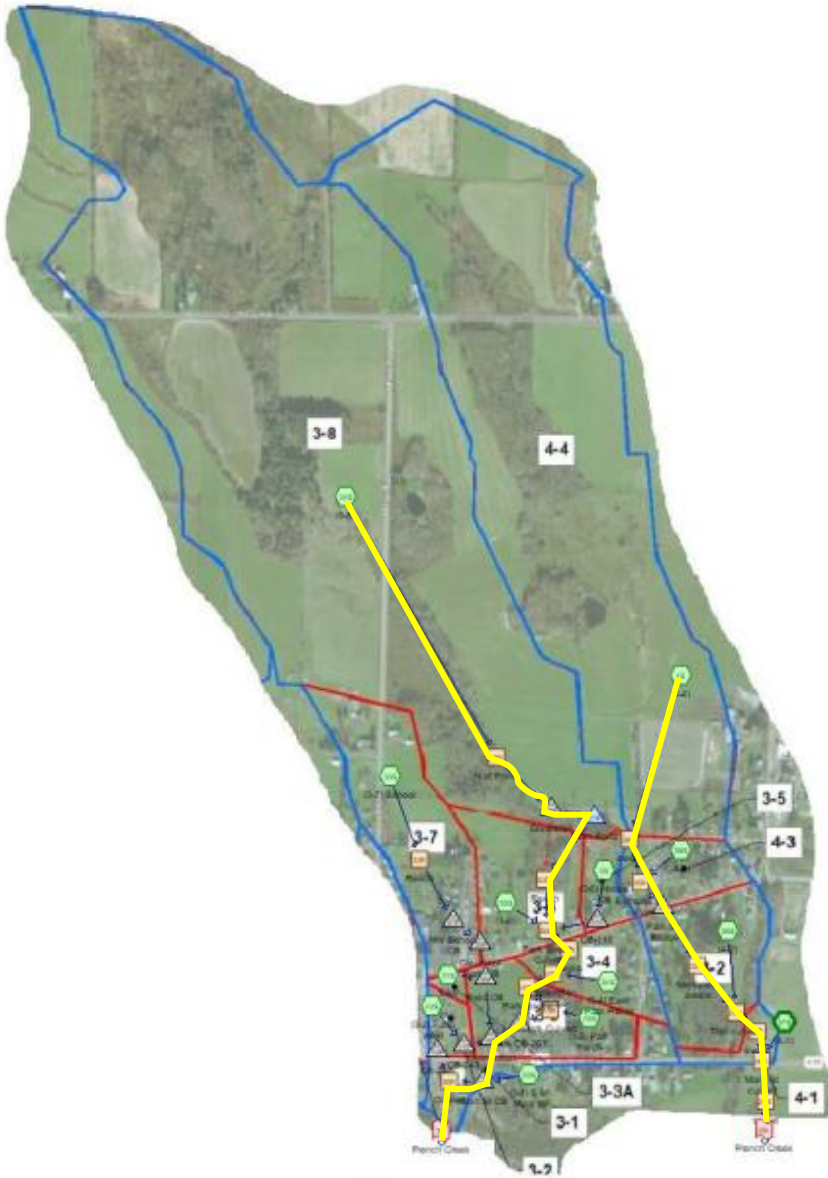
Figure 3-4: DA-3 & DA-4 Model

| Table 3-3: DA-3 and DA-4 Peak Flow and Flooding Locations | | |
| 1-Year Storm | 68 | <ul style="list-style-type: none"> <li>• Within the reach west of Columbia St. north of Sherman High School in residents' backyards</li> <li>• Sherman High School athletic fields just southwest of the baseball diamond</li> <li>• Sherman High School athletic fields just south of Park St. and east of the faculty lot</li> <li>• Within the reach northwest of the Sherman Community Nature Center pond</li> <li>• Within a reach north of Sherman Mayville Rd. just east of Chautauqua-Rails-To-Trails</li> </ul> |
| 10-Year Storm | 84 | <ul style="list-style-type: none"> <li>• Within the reach that borders the Sherman High School athletic fields to the south</li> <li>• Within the reach south of Park St. and east of East St.</li> <li>• Overtopping the east side of Edmunds St.</li> </ul> |

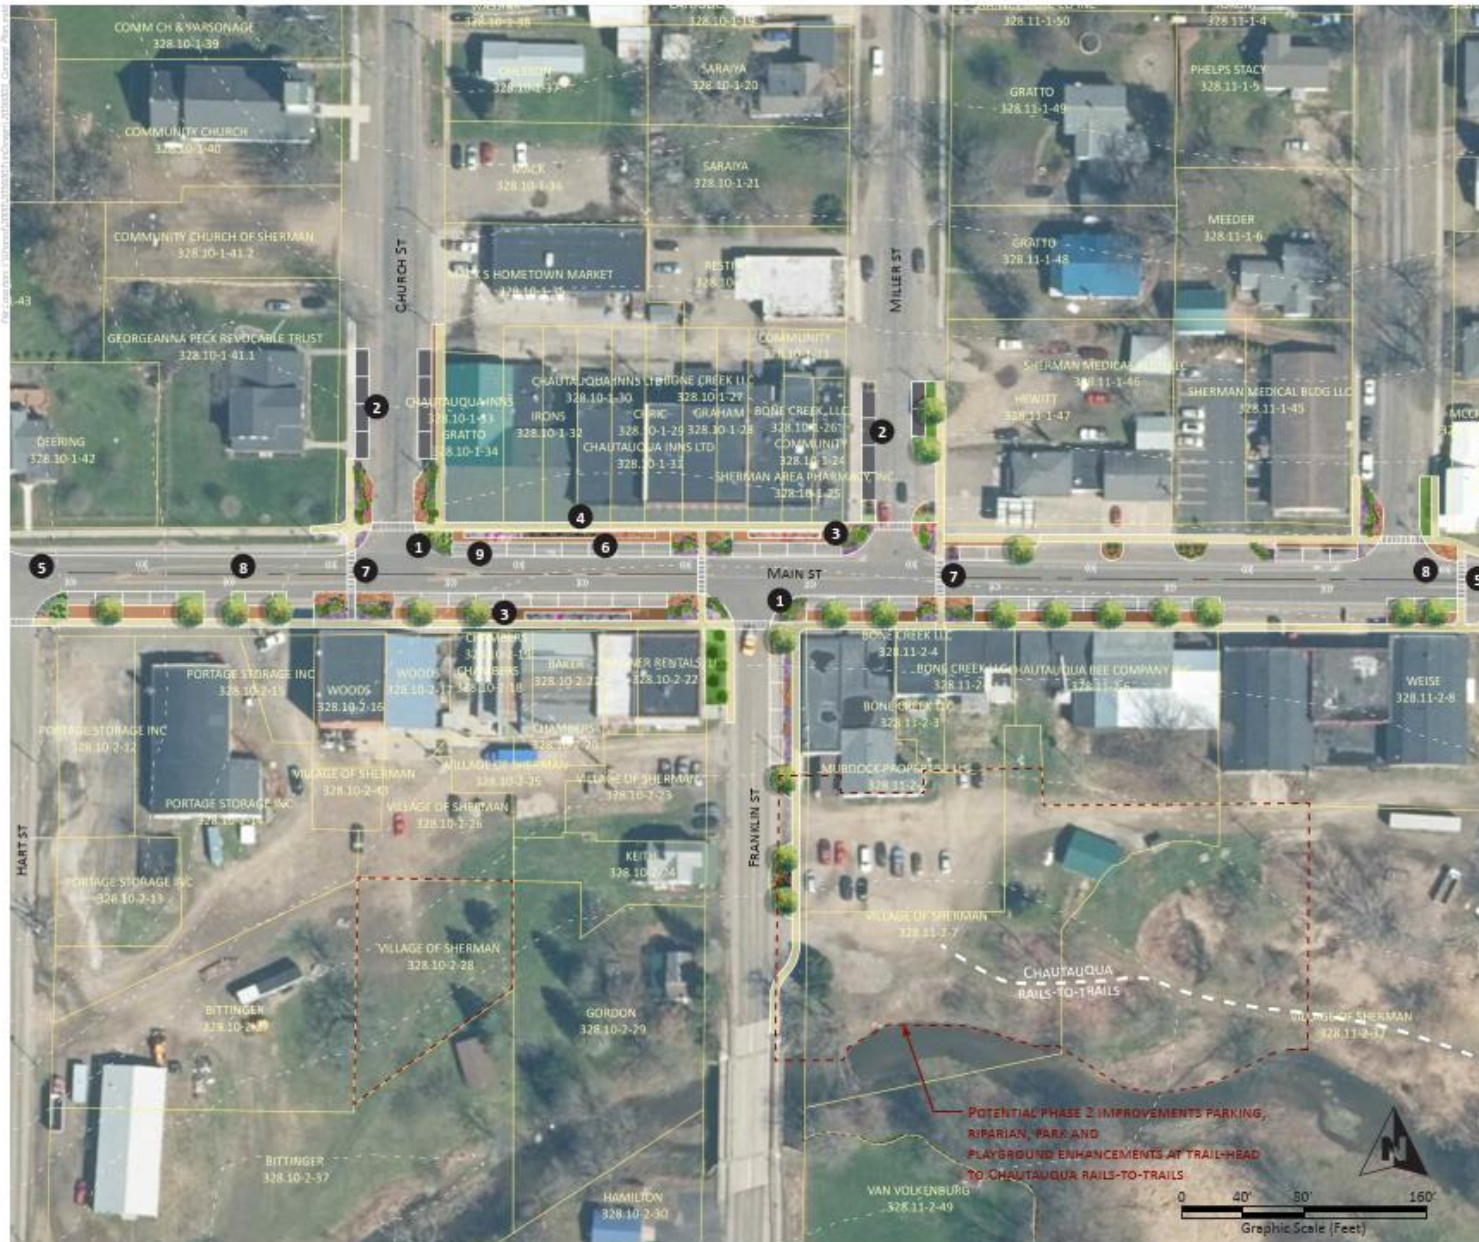
- 1 BIO-RETENTION BUMPOUTS**  
 Installation of bio-retention bumpouts with curb drops to capture stormwater runoff, for a total coverage of 10,000 SF.
- 2 PERMEABLE ASPHALT PARKING**  
 Replacement of existing pavement, for a total coverage of 3,500 SF.

- 3 FLEXIBLE POROUS PAVEMENT**  
 Replacement of existing pavement with flexible porous pavement for snow storage and infiltration. Place stormwater street trees with CU structural soil where feasible. 6,500 SF coverage.

- 4 CONCRETE SIDEWALK**  
 Concrete sidewalks pitched towards flexible porous pavement for infiltration. Install granite curbing with 6" reveal to direct roadway runoff to curb drops.

- 5 EASTERN & WESTERN VILLAGE GATEWAYS**  
 Visually notify the driver that they are entering a dense residential area...and to SLOW DOWN!
- 6 DOWNSPOUT DISCONNECTIONS**  
 Installation of rain barrels and stormwater to planters capture and re-use stormwater from downspouts, for a total coverage of 1,060 SF.

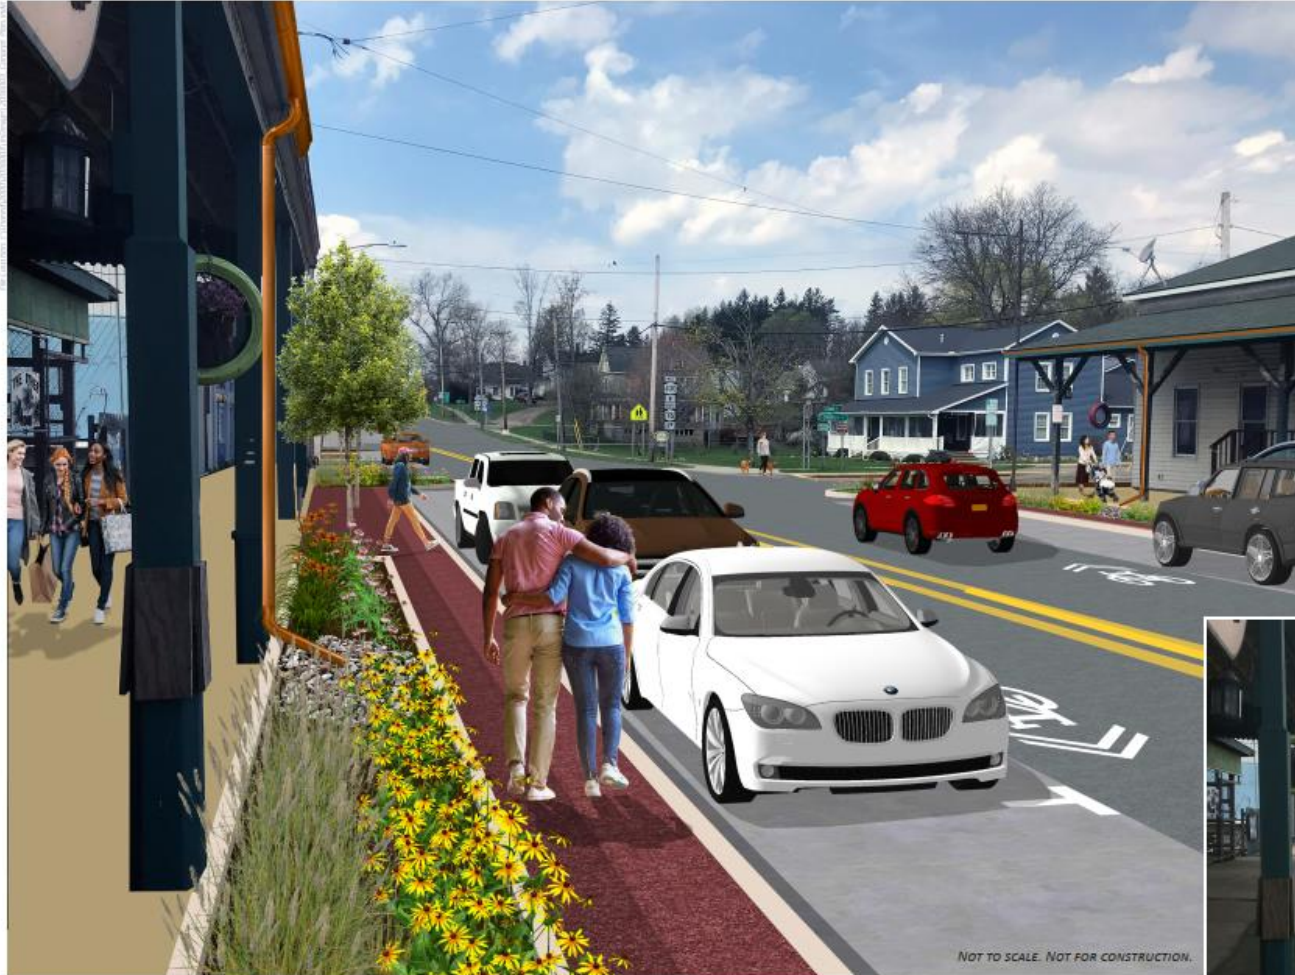
PROPOSED CONCEPT SKETCH

Village of Sherman  
Stormwater Infrastructure Preliminary Engineering Report  
Project No. 1: Perspective on Main Street (view west)  
January 2020

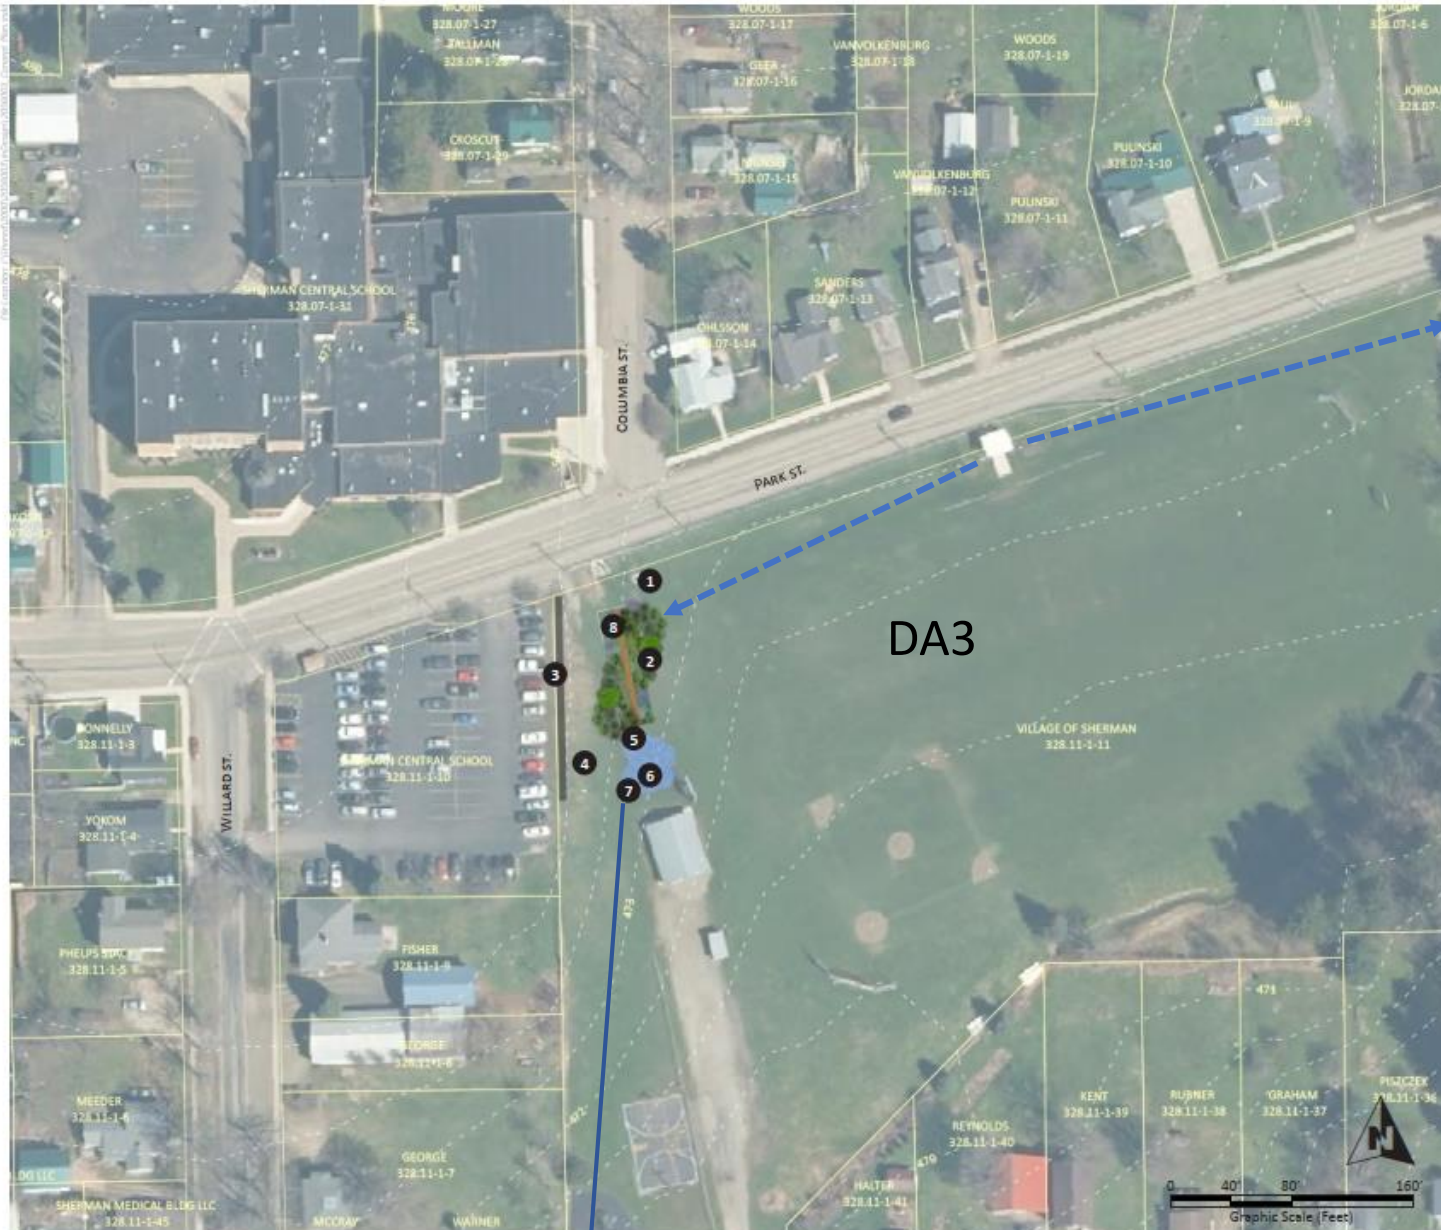
Village of Sherman  
 Stormwater Infrastructure Preliminary Engineering Report  
 Project No. 2: Concept Plan  
 January 2020

- 1 **ISOLATION DIVERSION STRUCTURE**  
 First flush of stormwater runoff directed to offline bio-retention area via isolation diversion structure by modifying the existing catch basin. Higher flows would bypass the offline bio-retention area to stable downstream underground storm drainage to prevent localized flooding.

- 2 **BIO-RETENTION AREA**  
 Minor regrading surrounding area to act as a site low point, for a total coverage of 4,000 SF.
- 3 **STONE DIAPHRAGM**  
 Stone drop (pea gravel diaphragm) provided down-gradient of parking lot for initial treatment of parking lot sheet flow.

- 4 **GRASS FILTER STRIP**  
 Grass filter strip provided down-gradient of stone diaphragm for further pretreatment and to convey flow to the bio-retention area.

- 5 **CULVERT/LAND BRIDGE**  
 Culvert underneath land bridge connecting bio-retention areas to allow pedestrian travel to athletic fields from the adjacent parking lot.

- 6 **OVERFLOW/OUTLET**  
 Overflow/outlet control device that connects to existing underground stormwater infrastructure.
- 7 **IMPROVE WATER QUALITY**  
 Bio-retention vegetation and soils will uptake and filtrate water.

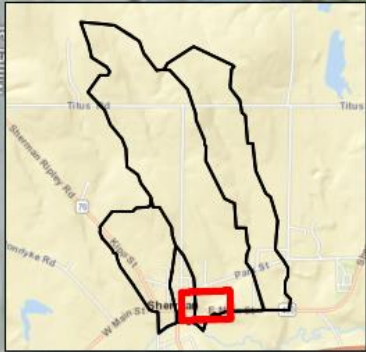
**OVERFLOW PIPE FROM  
BIORETENTION AREA**

Model Name: 'CB-243'  
Size: 48 inches  
Length: 30.4 feet  
Inlet Invert: 1,536.36  
Outlet Invert: 1,537.34  
Slope: -0.0322

Model Name: 'Park Culvert'  
Size: 36 inches  
Length: 218.2 feet  
Inlet Invert: 1,540.16  
Outlet Invert: 1,538.19  
Slope: 0.0090

Model Name: 'CB-203'  
Size: 36 inches  
Length: 32.4 feet  
Inlet Invert: 1,538.18  
Outlet Invert: 1,538.0  
Slope: 0.0059

Model Name: 'Connection'  
Size: 36 inches  
Length: 172.0 feet  
Inlet Invert: 1,538.0  
Outlet Invert: 1,537.06  
Slope: 0.0055

\*RECOMMEND INCREASING TO 48"
